Buchamer Inspection Services Ltd.

Property Inspection Report

Property Address: 114 West Windsor Road, North Vancouver

Date of Inspection: 02/12/2024

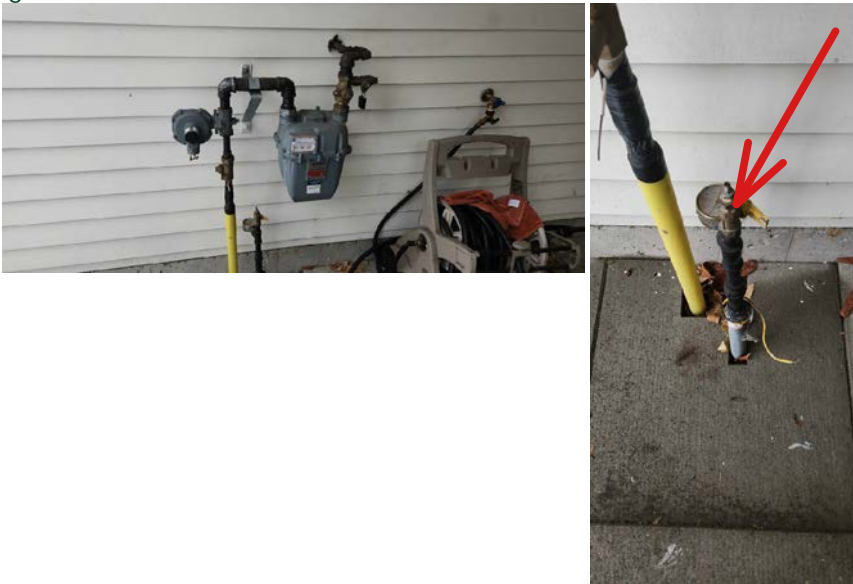
1. Gas Meter Location East side of the house. Confirm if the extra piping located by the gas meter is for a back up generator.

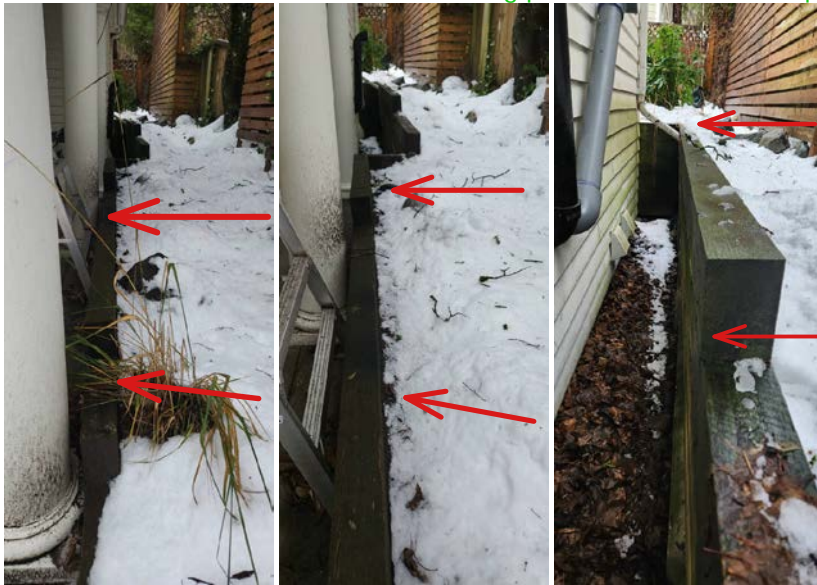
1. Retaining Wall(s) Railroad ties. Evidence the East retaining wall is leaning. To be replaced to prevent further deterioration and/or failure. After taking possession consult a qualified contractor for recommendations and costs.

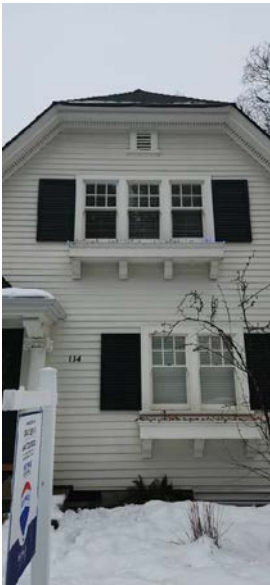
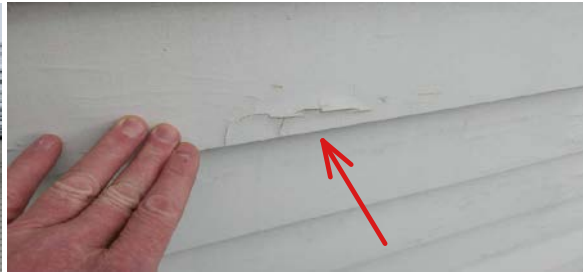
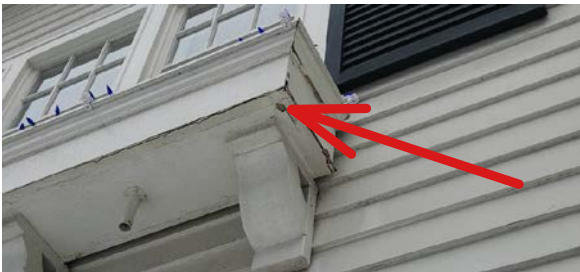
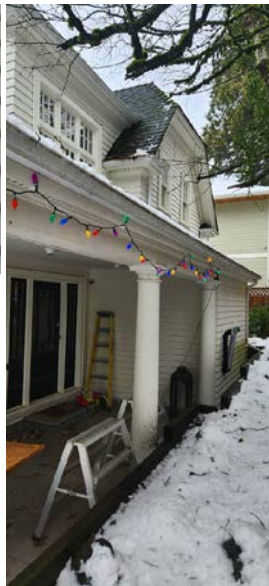
1. Primary Surface Wood. Sealed. Evidence the wood is weathered, cracking and peeling in multiple locations. To be repaired in the spring to prevent further deterioration and moisture damage. Consult a qualified contractor for recommendations and costs.

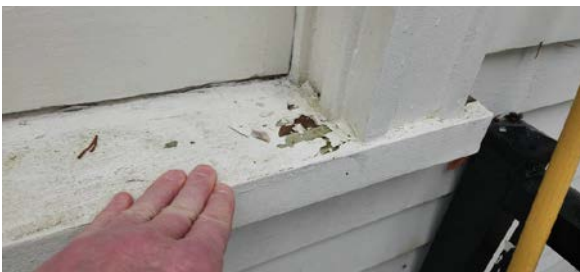
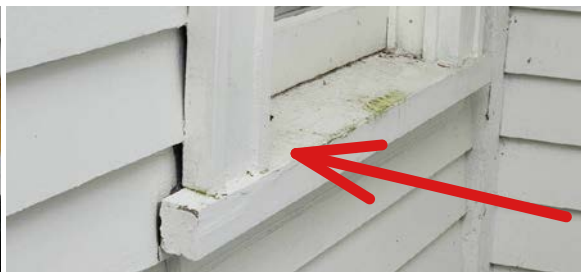
2. Trim Wood sealed., Doors., Windows. Evidence trim around multiple the windows is weathered/moisture damage, To be repaired this spring to prevent further deterioration and moisture damage. Consult a qualified contractor for recommendations and costs.

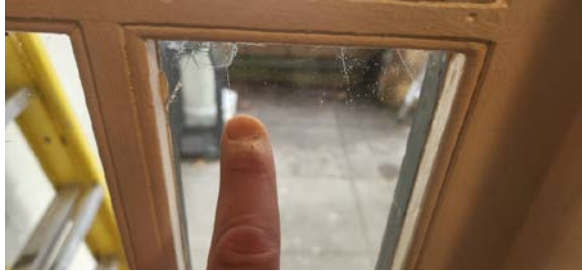
3. Main entrance. Main hallway. Den. Livingroom. Third level hallway. Living Space Window(s) Inspecting window blinds or drapes is not part of this inspection process. Consult vendor for functionality. Upon possession inspect blinds/drapes for condition. Evidence of several of the windows on the main level have broken glazing. To be repaired.

Also a number of windows are painted shut and/or hardware is missing or damage. To be repaired. Consult a qualified contractor for recommendations and costs.

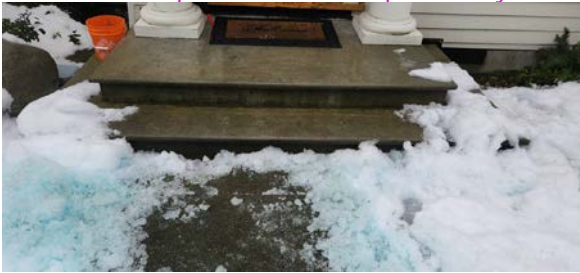
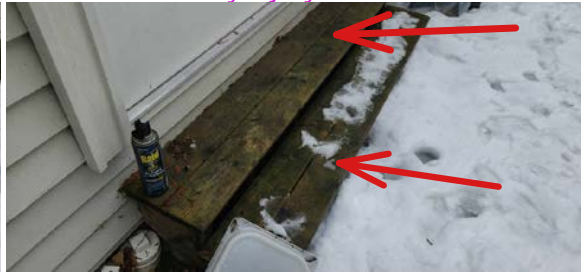
1. Steps Concrete Poured., Wood not sealed. **Wood steps to be sealed to prevent deterioration. Install anti slip material to steps. Safety issue. Potential of bodily injury.**

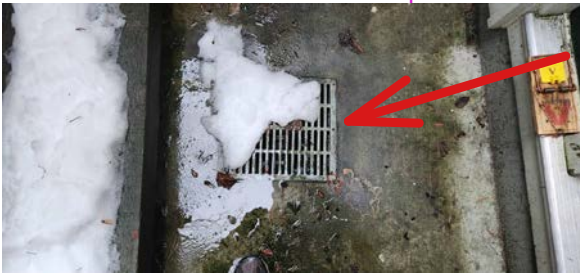
2. Stairwell(s) Concrete Poured. **Drain to be cleaned several times a years to prevent water entering the house causing damage to surfaces, belongings and the structure.**

Install anti slip material to stairs. Safety issue. Potential of bodily injury.

Wood stairs are to be sealed to prevent deterioration.

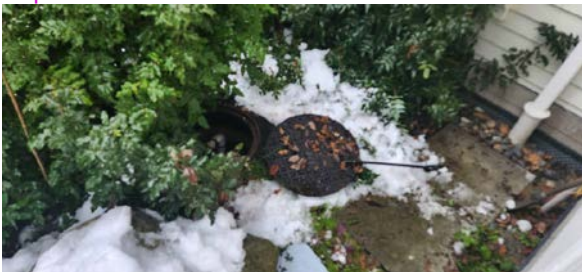
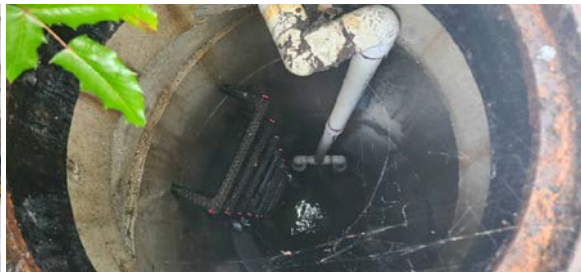
4. Exterior Mechanical Sump(s) Front of the house. The system should be serviced and tested annually before the fall, for performance, longevity and to prevent water from entering the house/basement/crawlspace and causing damage to surfaces, belongs and the structure. Consult vendor for functionality and service history. After taking possession consult a qualified contractor for annual servicing, recommendations, remaining life span and replacement costs.

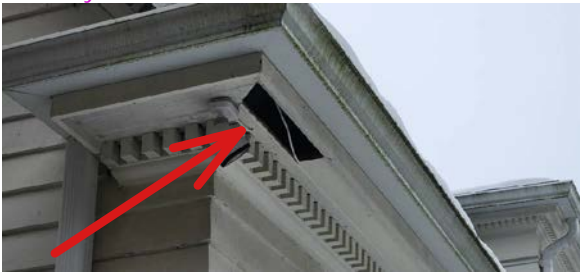
7. Soffit Wood sealed. Closed with no venting. **Close the opening located on the North/East corner to prevent pest activity.**

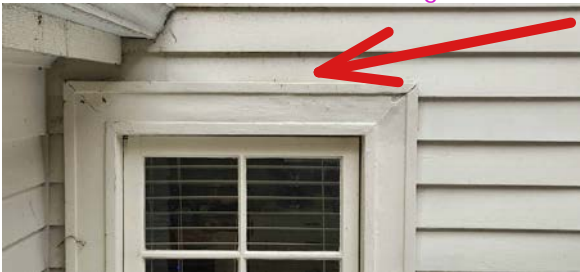
8. Flashing Flashing is missing over lower windows and doors. **Potential source of water penetration. Will require annual maintenance and caulking.**

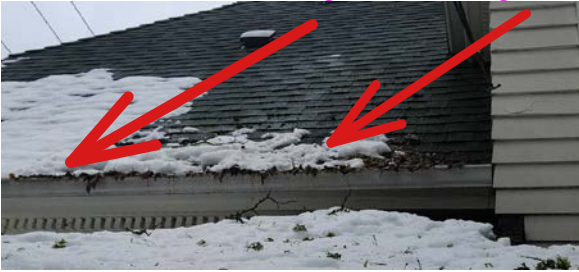
14. #1 of 1. Roof Surface Gutter(s)/Drain(s) Metal. **Recommending cleaning of the gutters and drains, to be cleaned on a regular basis as part of an annually maintenance program. Clogged gutter or drains can cause water to run down exterior walls causing water damage to the siding and the structure.**

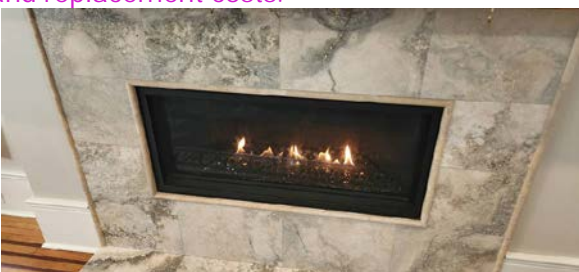
16. Type/Condition Gas metal system. **Gas fireplace should be serviced on a annual basis, for performance and safety. Consult vendor for service history. Consult a qualified fireplace contractor for servicing, remaing life span and replacement costs.**

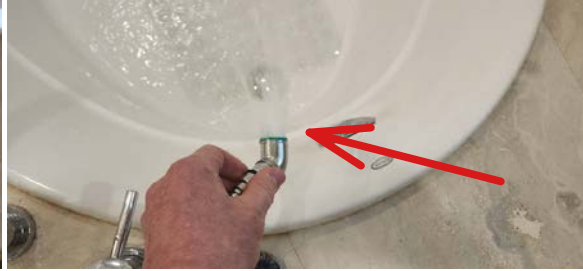
18. #3 of 3. Third level. Bathroom Tub Regular - Evidence hand sprayer is damaged. To be repaired.

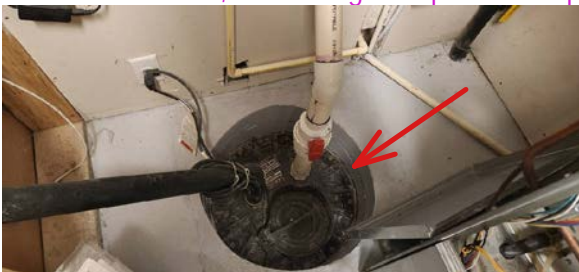
24. Interior Sump(s) Location Basement. Mechanical - System to be serviced annually for performance and longevity and to prevent water/sewage from damaging the surfaces, belongings and the structure. Consult vendor for functionality and service history. Once taking possession consult a qualified plumbing contractor for servicing, recommendations, remaining life span and replacement costs.

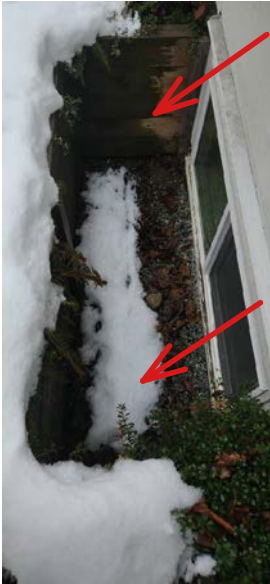
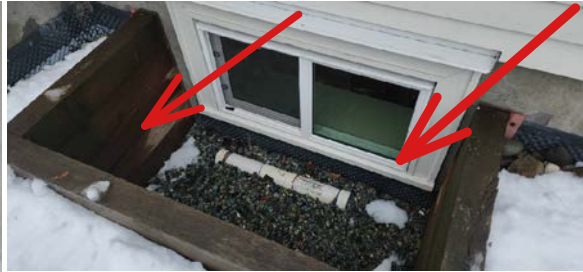
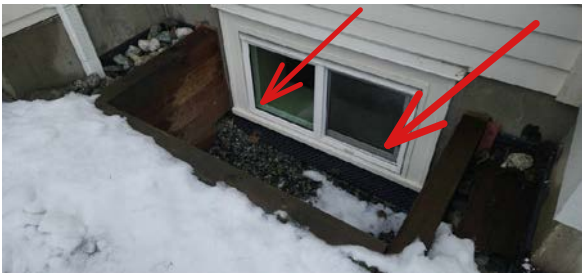
1. Window Well(s) Rail road ties., Gravel base., Drain not visible. Unable to inspect. Evidence railing or cover is missing. Potential of bodily injury. Safety issue. After possession to be installed. Consult a qualified contractor for recommendations and costs.

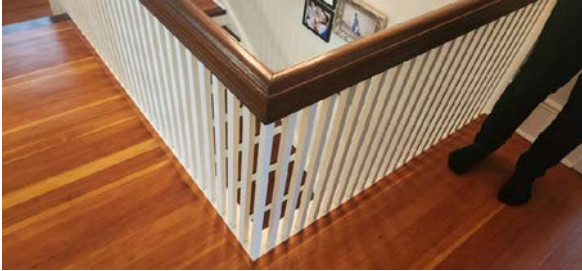
5. Main entrance. Main hallway. Den. Livingroom. Third level hallway.
Living Space Stairs Plank. Evidence the hand railing located on the second level is to low. Safety issue. Potential of bodily injury. Railing is be a minimum of 34 inches. To be repaired. After taking possession consult a qualified contractor for recommendations and costs.

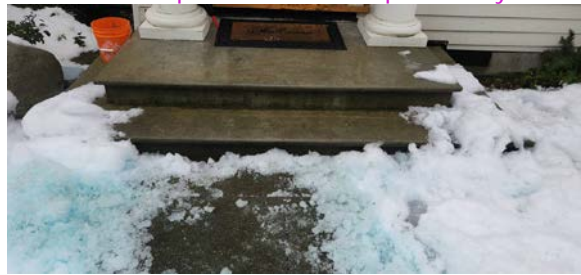
Steps Concrete Poured., Wood not sealed. Wood steps to be sealed to prevent deterioration.
Install anti slip material to steps. Safety issue. Potential of bodily injury.

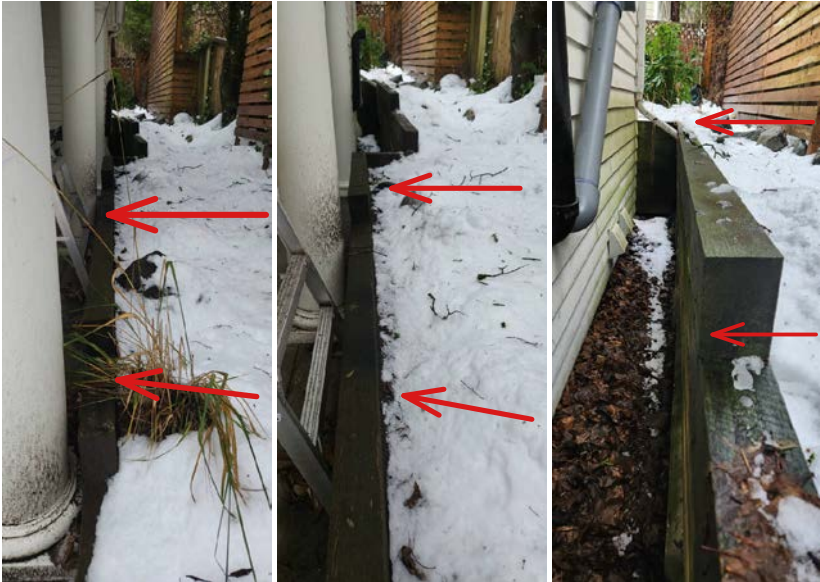
Retaining Wall(s) Railroad ties. Evidence the East retaining wall is leaning. To be replaced to prevent further deterioration and/or failure. After taking possession consult a qualified contractor for recommendations and costs.

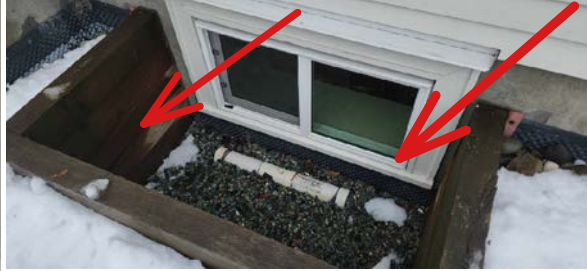
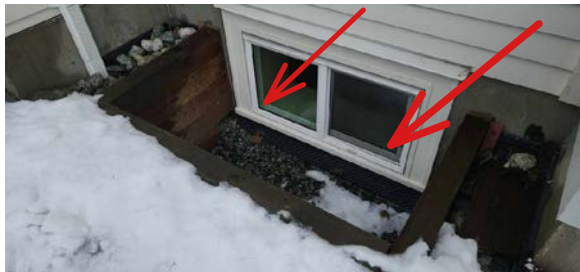
Window Well(s) Rail road ties., Gravel base., Drain not visible. Unable to inspect. Evidence railing or cover is missing. Potential of bodily injury. Safety issue. After possession to be installed. Consult a qualified contractor for recommendations and costs.

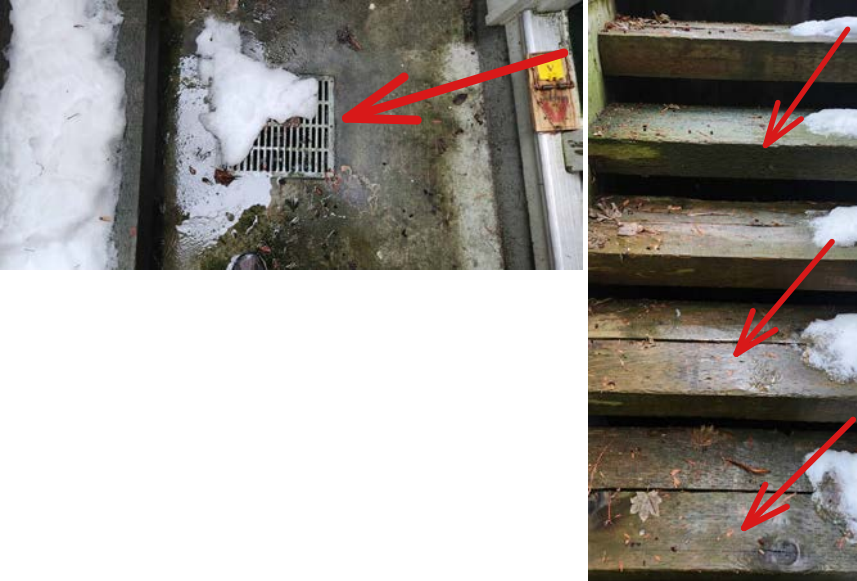
Stairwell(s) Concrete Poured. Drain to be cleaned several times a years to prevent water entering the house causing damage to surfaces, belongings and the structure.

Wood stairs are to be sealed to prevent deterioration.

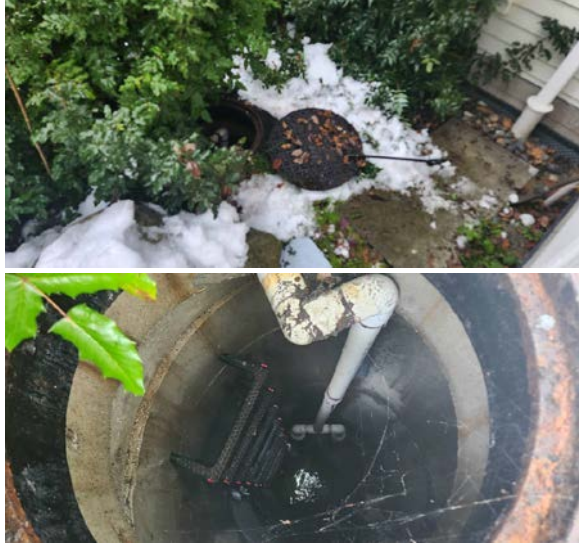
Exterior Mechanical Sump(s) Front of the house. The system should be serviced and tested annually before the fall, for performance, longevity and to prevent water from entering the house/basement/crawlspace and causing damage to surfaces, belongs and the structure. Consult vendor for functionality and service history. After taking possession consult a qualified contractor for annual servicing, recommendations, remaining life span and replacement costs.

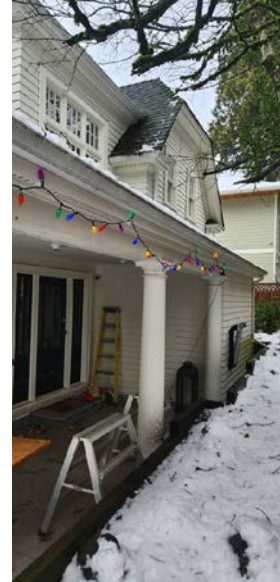
5. Repair or Replacement Required Primary Surface Wood. Sealed. Evidence the wood is weathered, cracking and peeling in multiple locations. To be repaired in the spring to prevent further deterioration and moisture damage. Consult a qualified contractor for recommendations and costs.

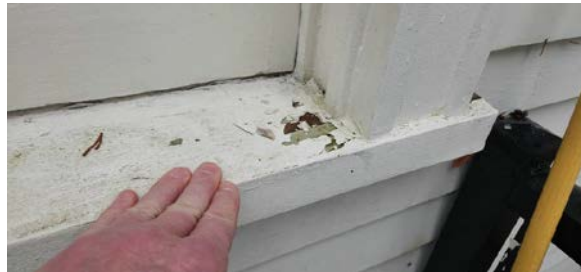
6. Repair or Replacement Required Trim Wood sealed., Doors., Windows. Evidence trim around multiple the windows is weathered/moisture damage, To be repaired this spring to prevent further deterioration and moisture damage. Consult a qualified contractor for recommendations and costs.

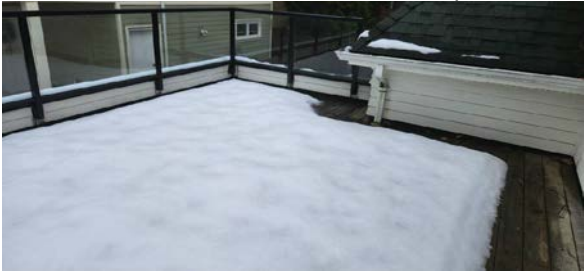
7. Maintenance Required	Drain(s) Not visible at time of inspection. Unable to inspect. <i>The drains to be cleaned several times a year to prevent ponding of water entering the house and damaging the structure and surfaces.</i>
8. Not Inspected	Membrane Not visible at time of inspection. Unable to inspect.

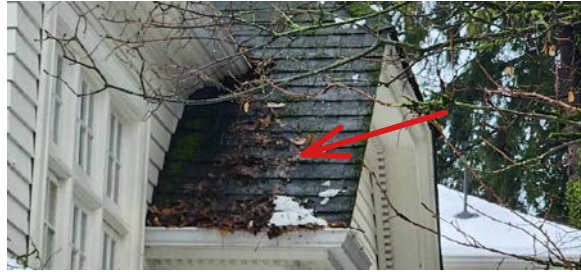
Roof's Condition **Remove leafs and moss.**

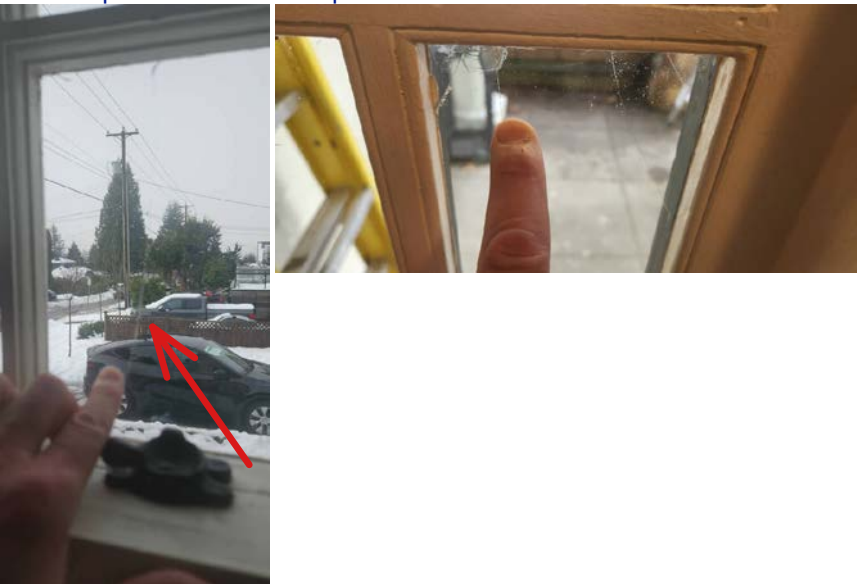
- 14. Inspected Wall(s) Drywall or plaster. Sealed.
- 15. Repair or Replacement Required Window(s) Inspecting window blinds or drapes is not part of this inspection process. Consult vendor for functionality. Upon possession inspect blinds/drapes for condition. Evidence of several of the windows on the main level have broken glazing. To be repaired.

Also a number of windows are painted shut and/or hardware is missing or damage.
To be repaired. Consult a qualified contractor for recommendations and costs.

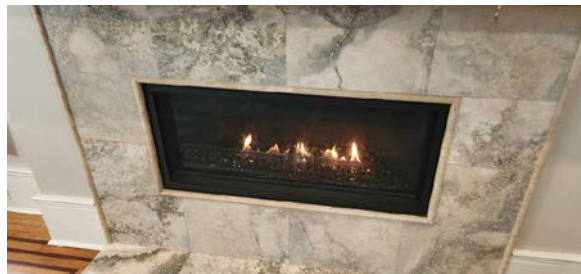
Type/Condition Gas metal system. Gas fireplace should be serviced on a annual basis, for performance and safety. Consult vendor for service history. Consult a qualified fireplace contractor for servicing, remaing life span and replacement costs.

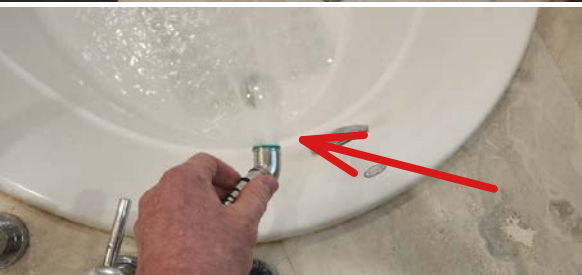
Toilet
Tub Regular - Evidence hand sprayer is damaged. To be repaired.

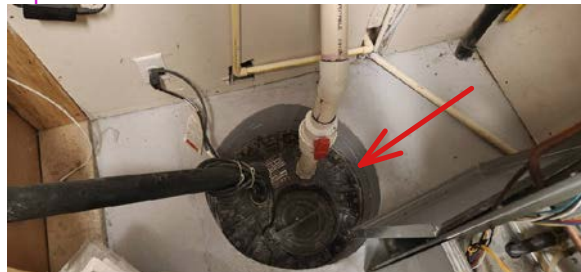
Interior Sump(s) Location Basement. Mechanical - **System to be serviced annually for performance and longevity and to prevent water/sewage from damaging the surfaces, belongings and the structure. Consult vendor for functionality and service history. Once taking possession consult a qualified plumbing contractor for servicing, recommendations, remaining life span and replacement costs.**

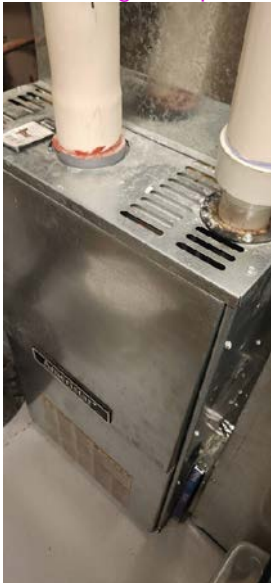
Condition Consult vendor for functionality and service history. System to be serviced annually before the fall for performance, longevity and safety. After taking possession consult a qualified HVAC contractor for annual servicing, remaining life span and replacement costs.
