Buchamer Inspection Services Ltd.

Property Inspection Report

Property Address: 114 West Windsor Road, North Vancouver

Date of Inspection: 02/12/2024

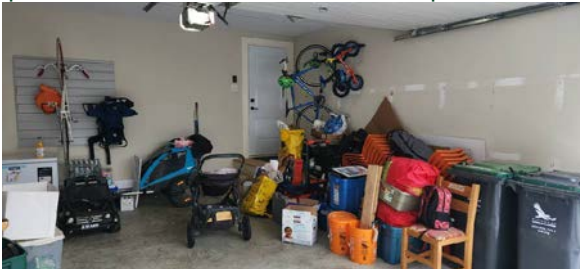
2. West side of the house. Garage/Carport Limited Interior Inspection Due to the occupants possessions. Upon possession check all surfaces for potential deficiencies and/or repairs.

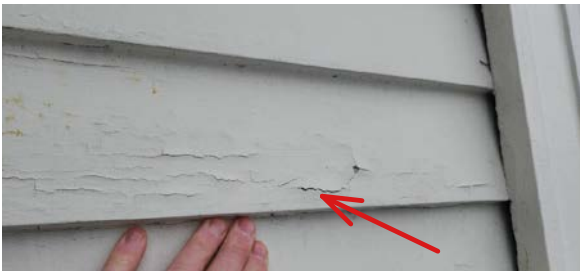
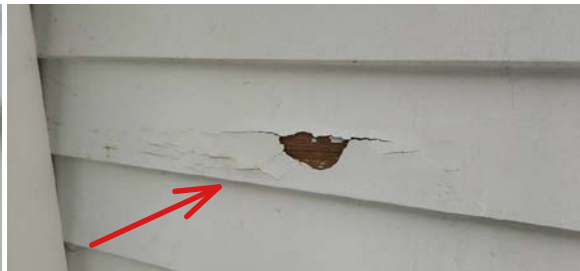
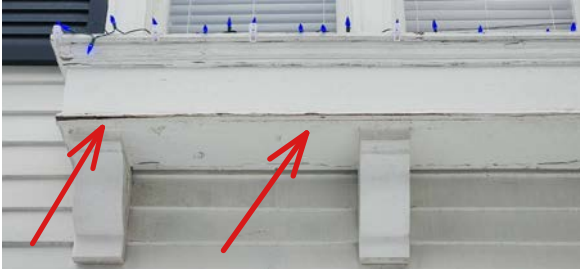
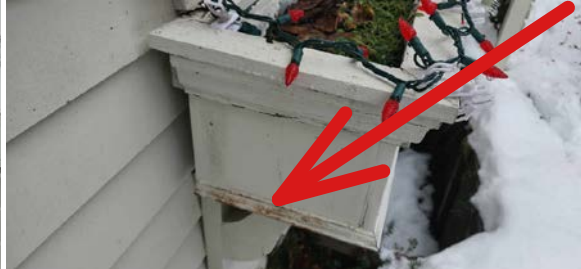
1. Primary Surface Wood. Sealed. Evidence the wood is weathered, cracking and peeling in multiple locations. To be repaired in the spring to prevent further deterioration and moisture damage. Consult a qualified contractor for recommendations and costs.

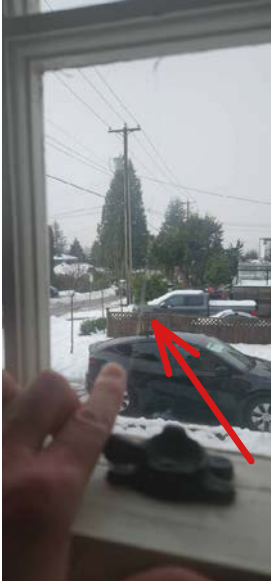
3. Main entrance. Main hallway. Den. Livingroom. Third level hallway. Living Space Window(s) Inspecting window blinds or drapes is not part of this inspection process. Consult vendor for functionality. Upon possession inspect blinds/drapes for condition. Evidence of several of the windows on the main level have broken glazing. To be repaired.

Also a number of windows are painted shut and/or hardware is missing or damage. To be repaired. Consult a qualified contractor for recommendations and costs.

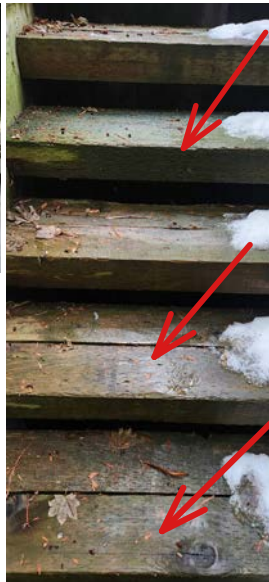
2. Stairwell(s) Concrete Poured. **Drain to be cleaned several times a years to prevent water entering the house causing damage to surfaces, belongings and the structure.**

Install anti slip material to stairs. Safety issue. Potential of bodily injury.

Wood stairs are to be sealed to prevent deterioration.

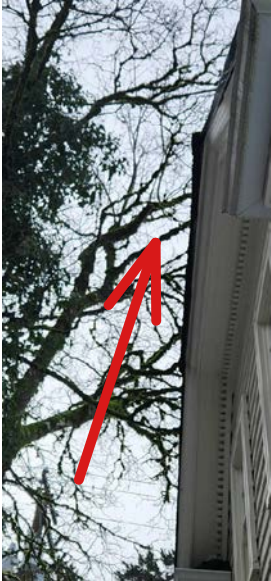
3. Vegetation Trees. Trim vegetation in contact with structure to prevent the potential of pest activity and/or moisture damage.

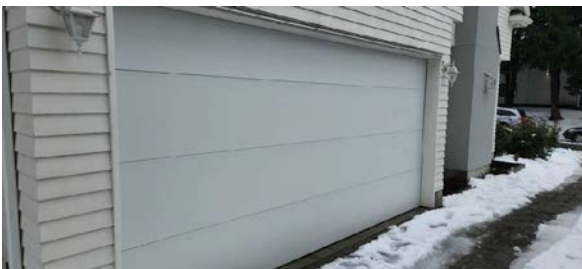
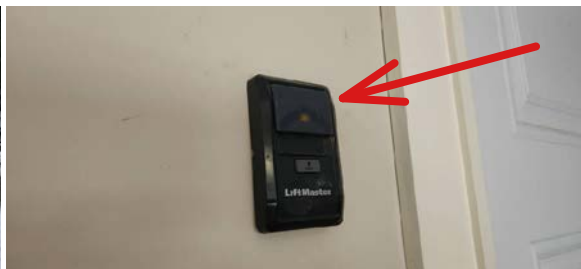
5. West side of the house. Garage/Carport Over Head Door(s) 1 door., Mechanical., With electronic eye door sensor. - Evidence the wall controller is loose. To be secured.

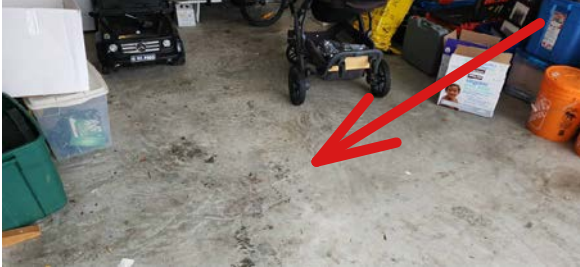
6. West side of the house. Garage/Carport Flooring Concrete poured. Not sealed. **Flooring to be sealed to prevent staining.**

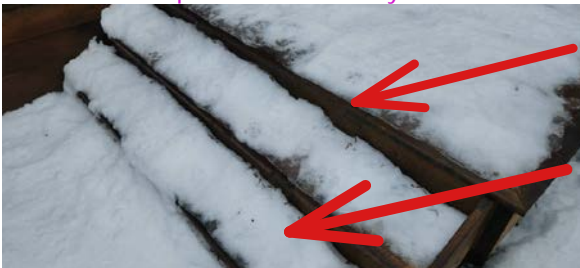
9. Steps Wood not sealed. **Steps to be sealed to prevent deterioration. Install anti slip material. Safety issue. Potential of bodily injury.**

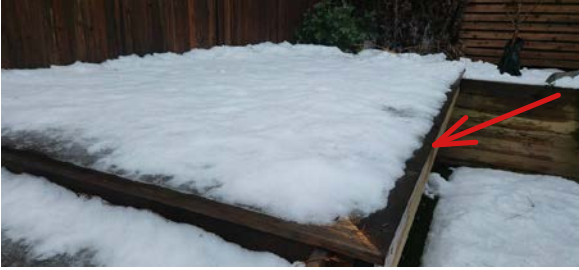
10. Flooring Wood not sealed. Limited inspection due to being snow covered. **Flooring to be sealed to prevent deterioration.**

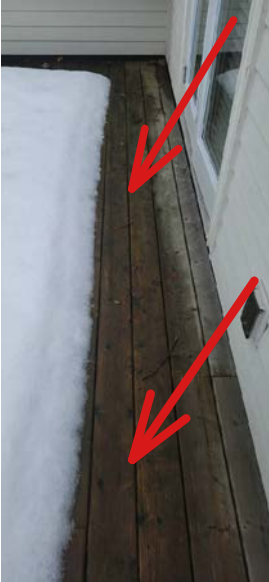
11. Flooring Wood not sealed. **The wood to be sealed to prevent deterioration.**

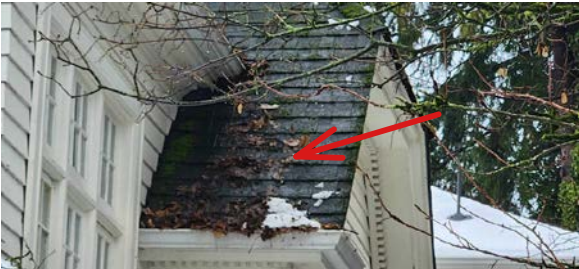
13. #1 of 1. Roof Surface Roof's Condition **Remove leafs and moss.**

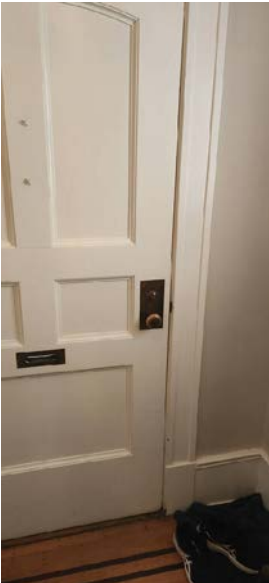
15. Main entrance. Main hallway. Den. Livingroom. Third level hallway. Living Space Exterior Door(s) Wood hinged. **Evidence door is difficult to open and close. To be repaired.**

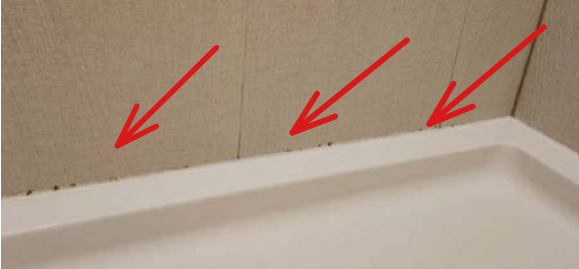
17. #2 of 3., Primary Bedroom Bathroom Shower Moisture test results are normal/dry at time of inspection., Tile.
Evidence caulking is deteriorated. To be replaced before use to prevent further deterioration and moisture damage.

Grout to be cleaned and sealed to prevent staining.

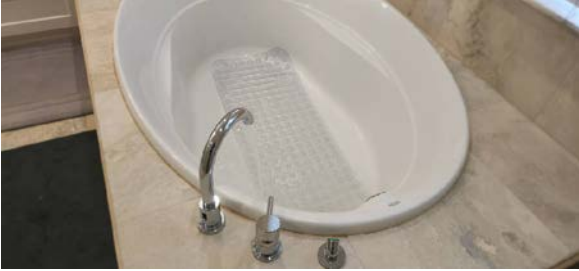
18. #3 of 3. Third level. Bathroom Tub Regular - Evidence hand sprayer is damaged. To be repaired.

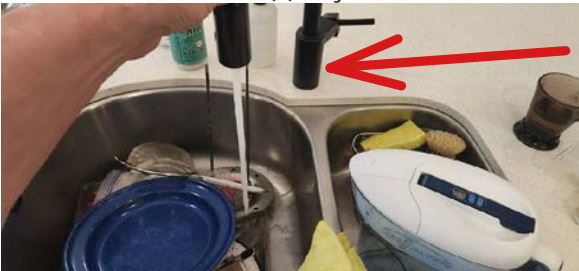
19. #1 of 1. Kitchen Sink(s) Qty - 01 - Evidence the faucet is loose. To be secured.

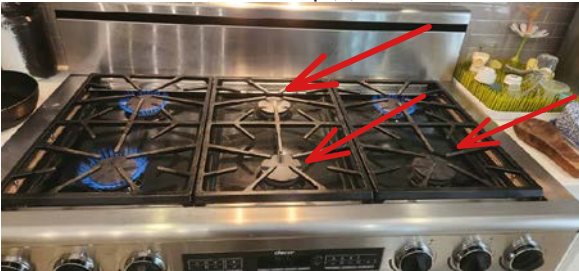
20. #1 of 1. Kitchen Cook Top(s) Gas., - Evidence several element(s)/burner(s) will not respond. To be repaired.

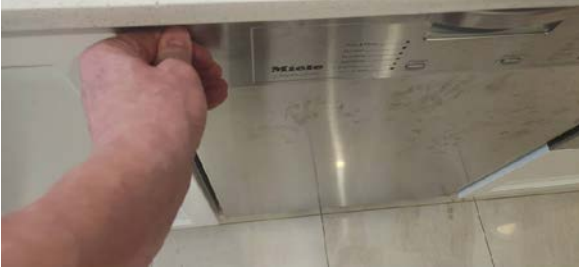
21. #1 of 1. Kitchen Dishwasher(s) Qty 01. Evidence the dishwasher was not mounted properly. To be repaired as desired.

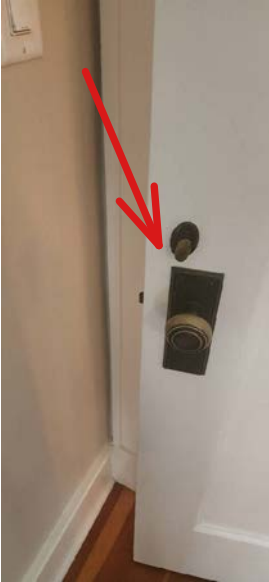
22. #2 of 3. Third level. Bedroom Interior Door(s) Wood hinged. Evidence door not closing properly. To be repaired.

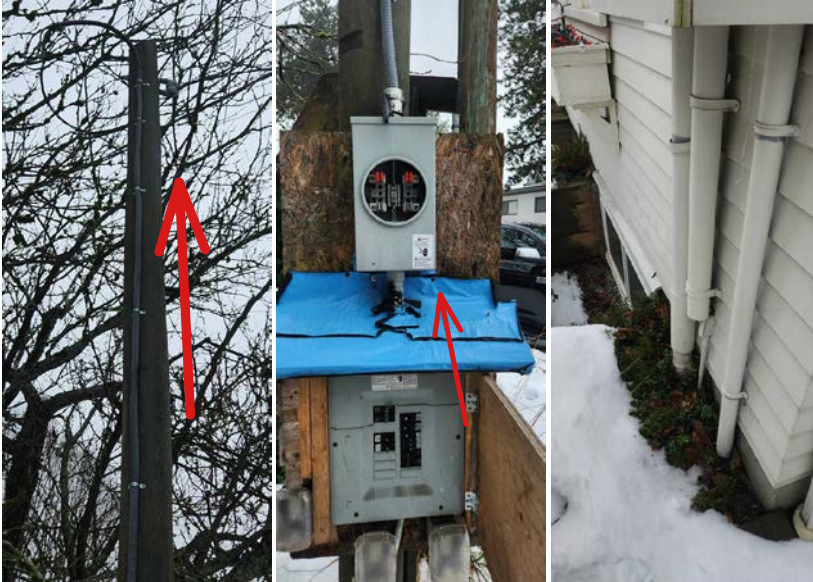
23. Service Drop Location Underground - Remove the old disconnected service drop and pole.

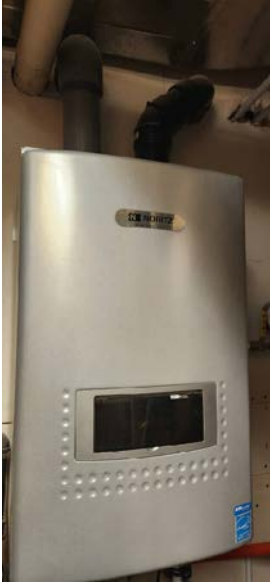
25. Basement. Mechanical room. Water Heater Condition **System should be serviced on a regular basis, for performance, longevity and safety. Consult vendor for service history. After taking possession consult a qualified HVAC contractor for annual servicing, remaining life span and replacement costs.**

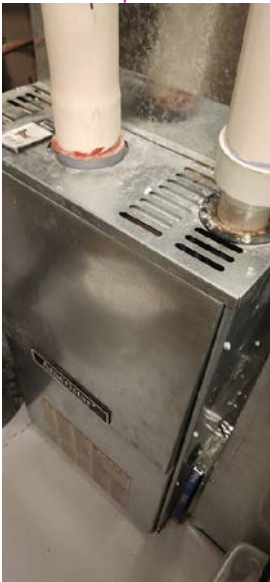
26. Basement. Mechanical room. Heating System Condition **Consult vendor for functionality and service history. System to be serviced annually before the fall for performance, longevity and safety. After taking possession consult a qualified HVAC contractor for annual servicing, remaining life span and replacement costs.**

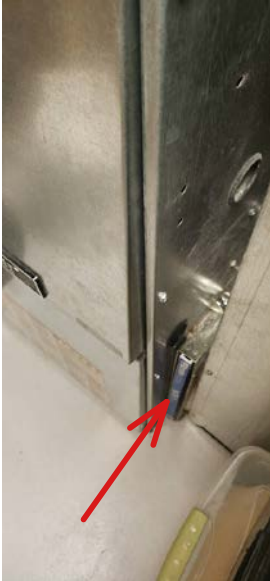
27. Basement. Mechanical room. Heating System Filter System Disposable. To be replaced approximately every four months.

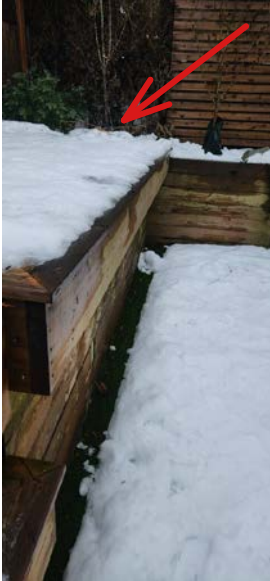
2. Railings/Wall(s) Missing railing observed. The railing to be installed. Safety issue. Potential of bodily injury. After taking possession consult a qualified contractor for recommendations and costs.

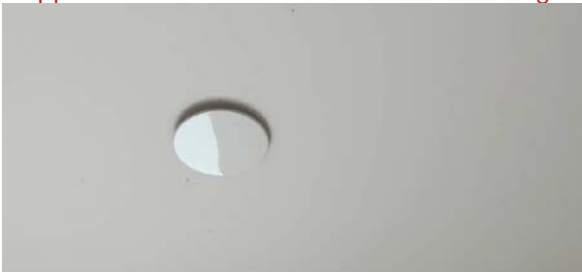
4. Testing of the fire suppression system is not part of this inspection process. Consult vendor for functionality and service history. To assure the system is functional in the event of a fire, upon possession consult a qualified fire suppression contractor for annual servicing and recommendations.

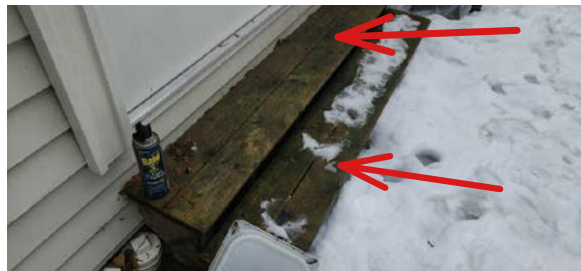
7. Maintenance Required

Steps Concrete Poured., Wood not sealed. Wood steps to be sealed to prevent deterioration.
Install anti slip material to steps. Safety issue. Potential of bodily injury.

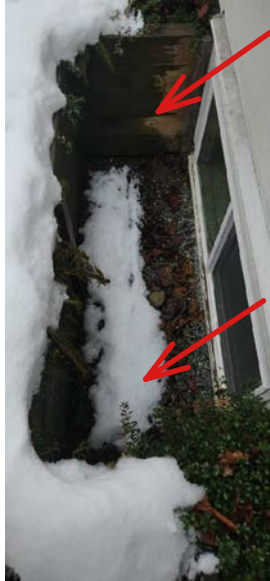
10. Safety Issue

Window Well(s) Rail road ties., Gravel base., Drain not visible. Unable to inspect. Evidence railing or cover is missing. Potential of bodily injury. Safety issue. After possession to be installed. Consult a qualified contractor for recommendations and costs.

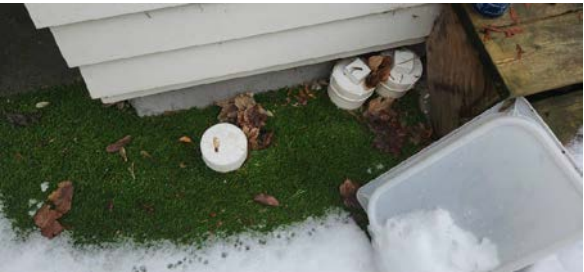
13. Inspected

Downspout Connection(s) Underground.
Footing Drain(s) PVC. Inspector is not able to determine where the water drains. After taking possession consult a qualified drainage contractor for an inspection and recommendations.

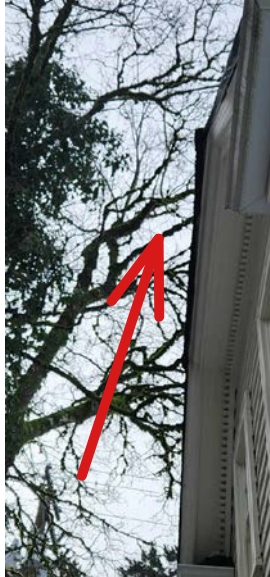
14. Maintenance Required

Vegetation Trees. Trim vegetation in contact with structure to prevent the potential of pest activity and/or moisture damage.

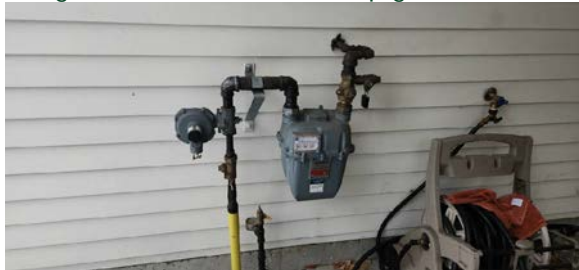
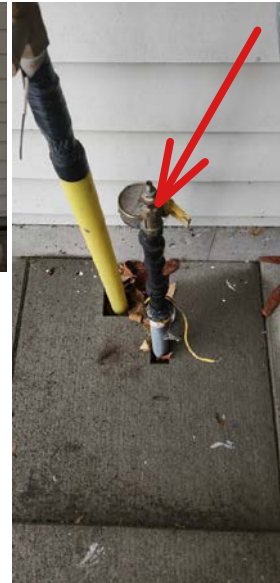
15. Further Investigation

Gas Meter Location East side of the house. Confirm if the extra piping located by the gas meter is for a back up generator.

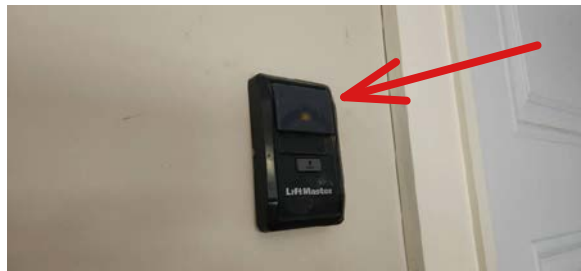
6. Maintenance Required

Evidence the wall controller is loose.

To be secured.

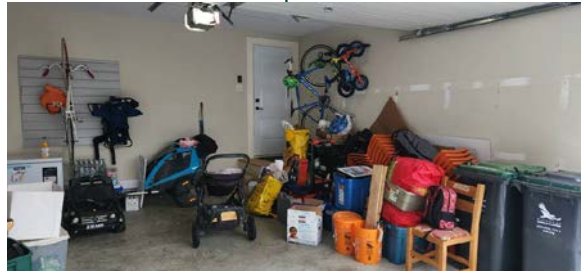
12. Further Investigation

Limited Interior Inspection Due to the occupants possessions. Upon possession check all surfaces for potential deficiencies and/or repairs.

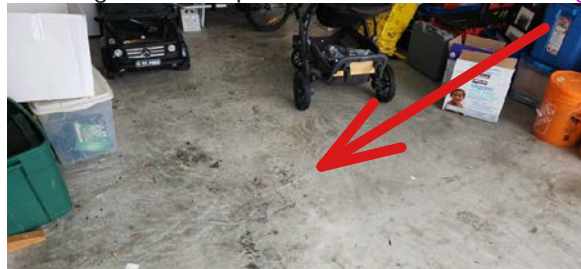
14. Maintenance Required

Flooring Concrete poured. Not sealed. Flooring to be sealed to prevent staining.

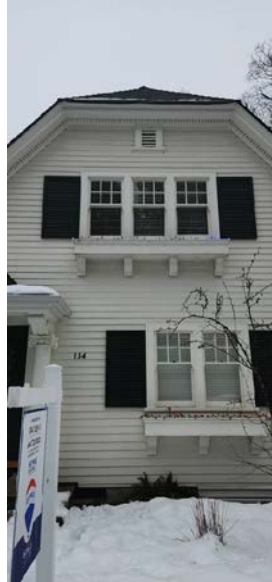
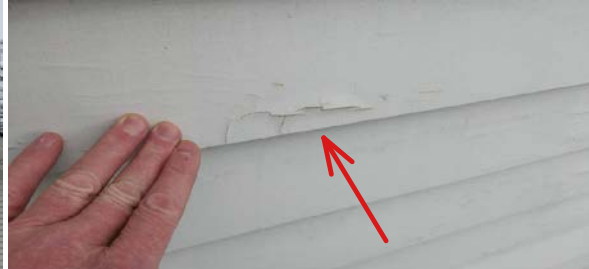
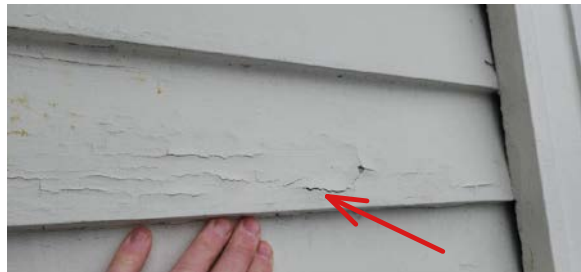
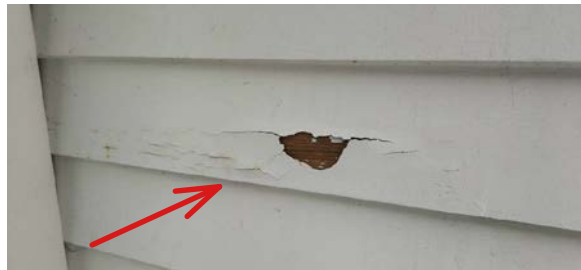
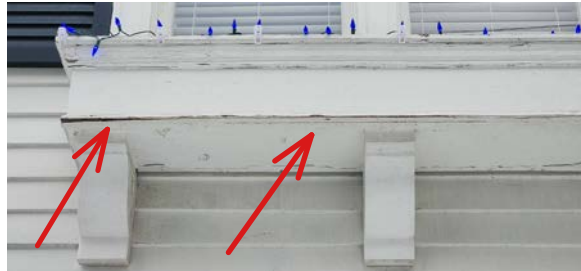
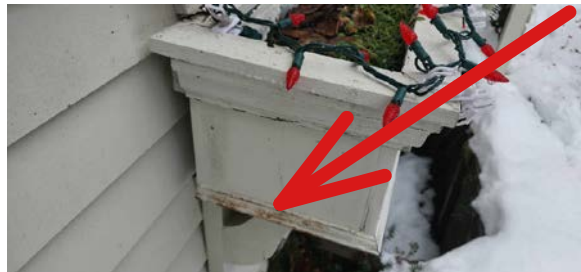
5. Repair or Replacement Required Primary Surface Wood. Sealed. Evidence the wood is weathered, cracking and peeling in multiple locations. To be repaired in the spring to prevent further deterioration and moisture damage. Consult a qualified contractor for recommendations and costs.

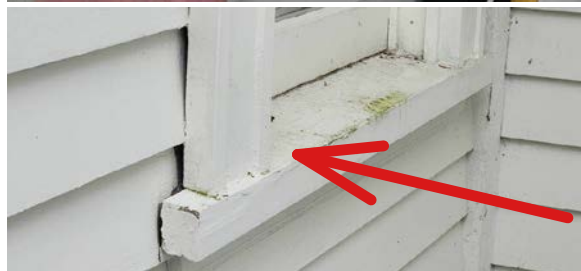
6. Repair or Replacement Required Trim Wood sealed., Doors., Windows. Evidence trim around multiple the windows is weathered/moisture damage, To be repaired this spring to prevent further deterioration and moisture damage. Consult a qualified contractor for recommendations and costs.

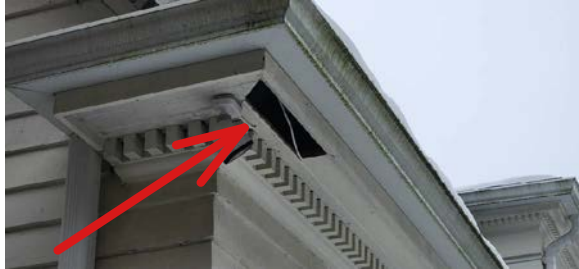
8. Maintenance Required

Soffit Wood sealed. Closed with no venting. **Close the opening located on the North/East corner to prevent pest activity.**

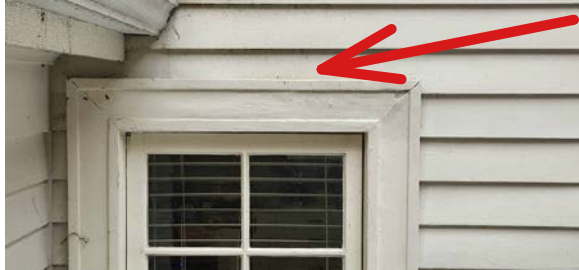
9. Maintenance Required

Flashing is missing over lower windows and doors. **Potential source of water penetration. Will require annual maintenance and caulking.**

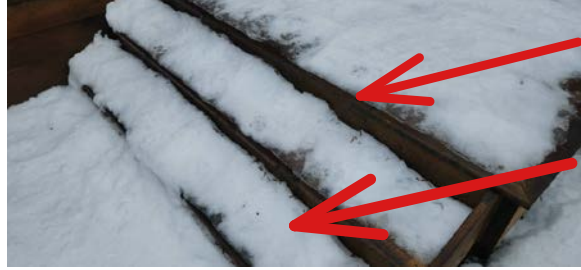
4. Maintenance Required

Steps Wood not sealed. Steps to be sealed to prevent deterioration. Install anti slip material. Safety issue. Potential of bodily injury.

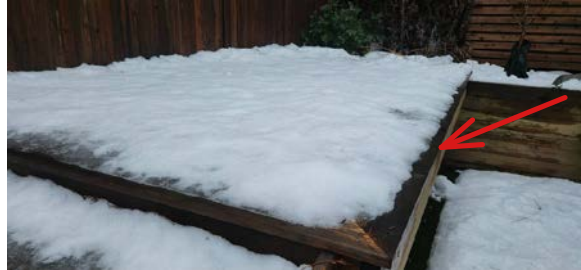
5. Maintenance Required

Flooring Wood not sealed. Limited inspection due to being snow covered. Flooring to be sealed to prevent deterioration.

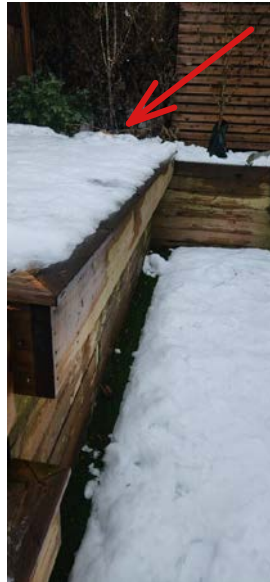
6. Safety Issue

Railings/Wall(s) Missing railing observed. The railing to be installed. Safety issue. Potential of bodily injury. After taking possession consult a qualified contractor for recommendations and costs.

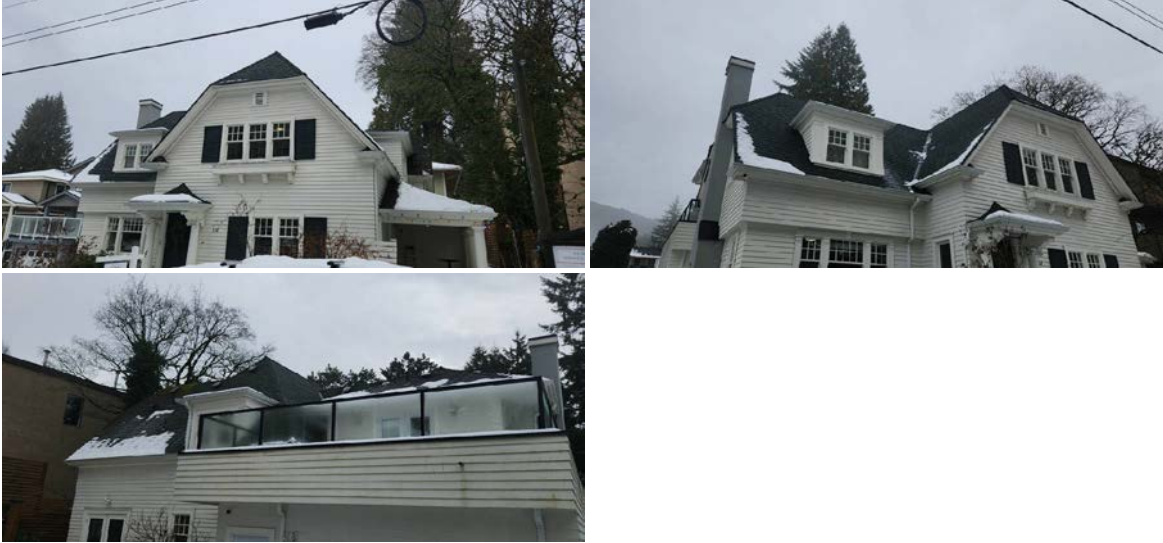
#1 of 1. Roof Surface

1. Type Of Roof Hip., Multiple levels., Steep slope.

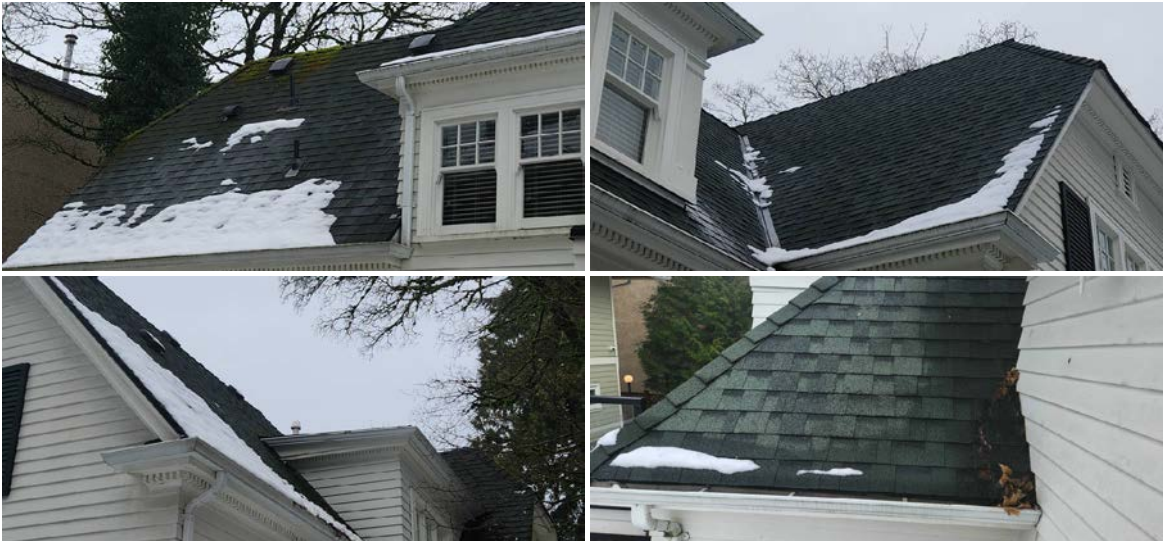
4. Roof Material Asphalt or fiberglass shingles. Material/condition mentioned here is for those only that were visible at the time of inspection.

Roof Limited Inspection This inspection is limited to the areas and components visible at the time of inspection. Due to some areas were not accessible/not visible, to ensure you are properly aware of all roof features and functionality. After taking possession consult a qualified roofing contractor for a detailed analysis, recommendations, remaining life span and replacement costs.

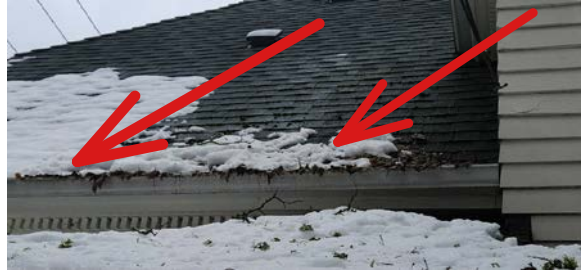
- 8. Maintenance Required

Gutter(s)/Drain(s) Metal. **Recommending cleaning of the gutters and drains, to be cleaned on a regular basis as part of an annually maintenance program. Clogged gutter or drains can cause water to run down exterior walls causing water damage to the siding and the structure.**

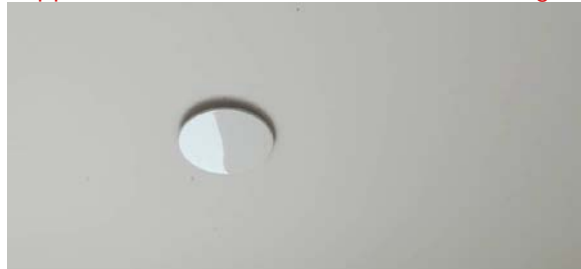
1. Safety Issue

Testing of the fire suppression system is not part of this inspection process. Consult vendor for functionality and service history. To assure the system is functional in the event of a fire, upon possession consult a qualified fire suppression contractor for annual servicing and recommendations.

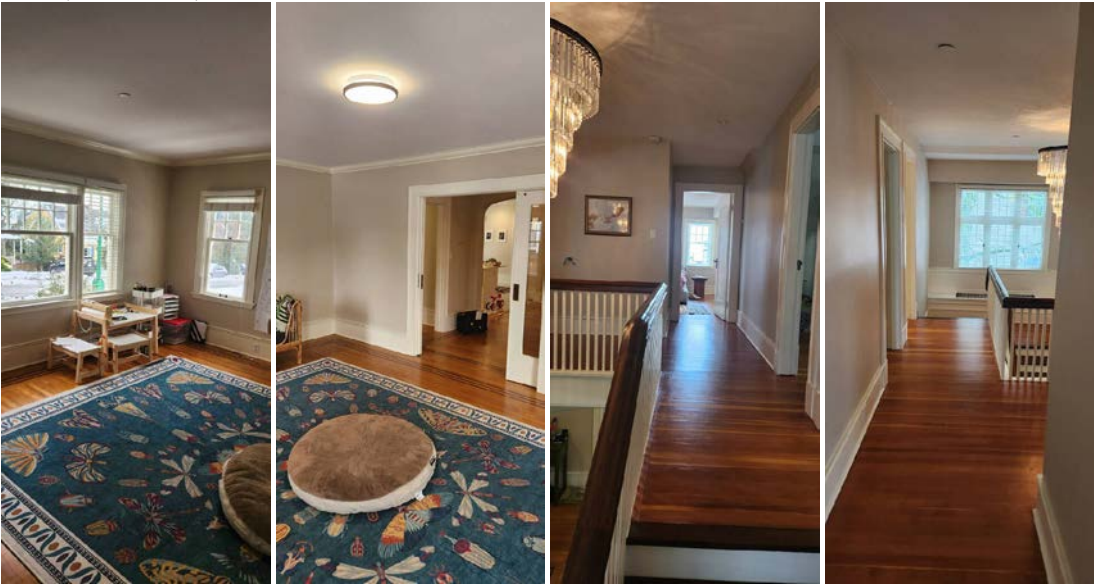
- 14. Inspected Wall(s) Drywall or plaster. Sealed.
- 15. Repair or Replacement Required Window(s) Inspecting window blinds or drapes is not part of this inspection process. Consult vendor for functionality. Upon possession inspect blinds/drapes for condition. Evidence of several of the windows on the main level have broken glazing. To be repaired.

Also a number of windows are painted shut and/or hardware is missing or damage.
To be repaired. Consult a qualified contractor for recommendations and costs.

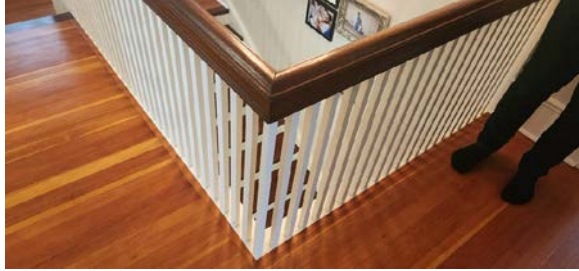
18. Safety Issue

Stairs Plank. Evidence the hand railing located on the second level is to low. Safety issue. Potential of bodily injury. Railing is be a minimum of 34 inches. To be repaired. After taking possession consult a qualified contractor for recommendations and costs.

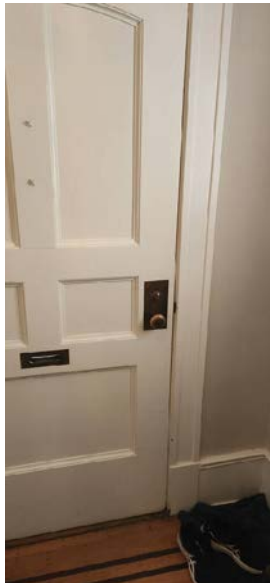
20. Maintenance Required

Exterior Door(s) Wood hinged. Evidence door is difficult to open and close. To be repaired.

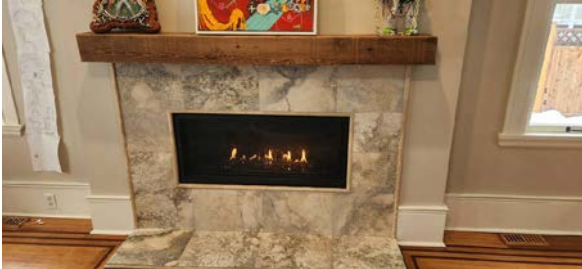
1. Location #1 of 1. Livingroom.

Type/Condition Gas metal system. Gas fireplace should be serviced on a annual basis, for performance and safety. Consult vendor for service history. Consult a qualified fireplace contractor for servicing, remaing life span and replacement costs.

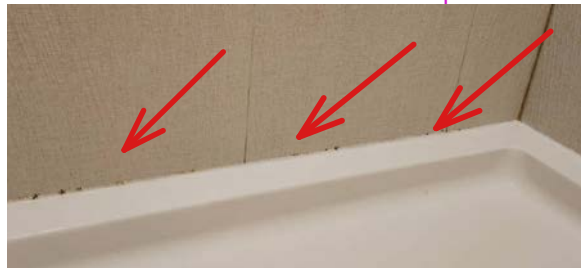
Shower Moisture test results are normal/dry at time of inspection., Tile. Evidence caulking is deteriorated. To be replaced before use to prevent further deterioration and moisture damage.

Grout to be cleaned and sealed to prevent staining.

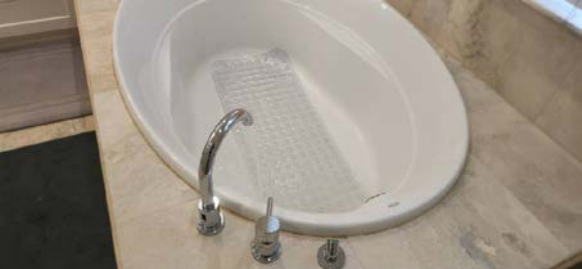
42. Inspected
43. Maintenance Required

Toilet
Tub Regular - Evidence hand sprayer is damaged. To be repaired.

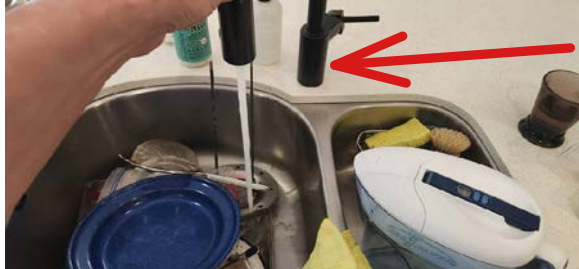
13. Maintenance Required

Sink(s) Qty - 01 - Evidence the faucet is loose. To be secured.

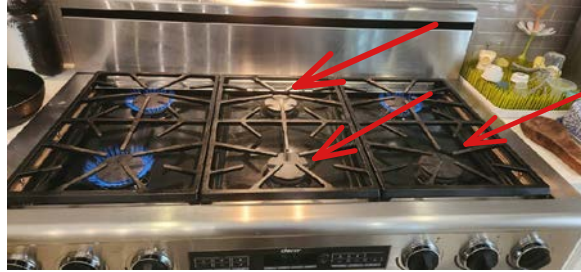
18. Maintenance Required

Cook Top(s) Gas., - Evidence several element(s)/burner(s) will not respond. To be repaired.

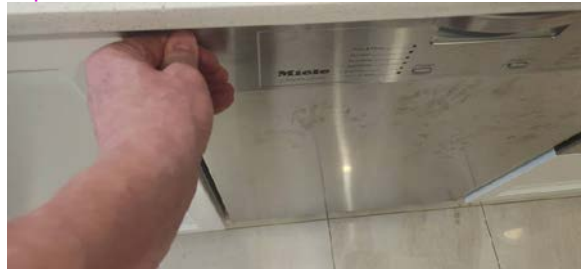
21. Maintenance Required

Dishwasher(s) Qty 01. Evidence the dishwasher was not mounted properly. To be repaired as desired.

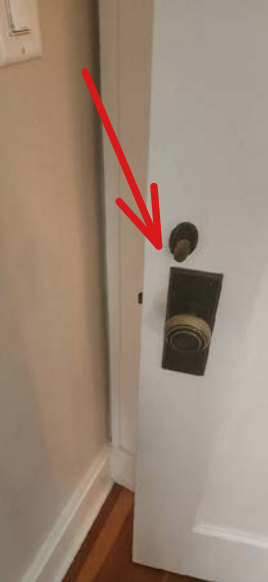
16. Maintenance Required

Interior Door(s) Wood hinged. Evidence door not closing properly. To be repaired.

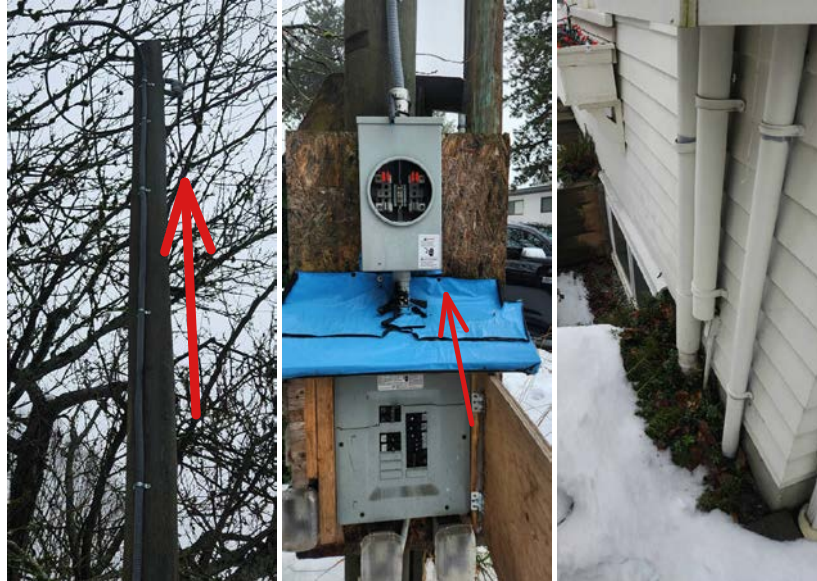
1. Maintenance Required

Service Drop Location Underground - **Remove the old disconnected service drop and pole.**

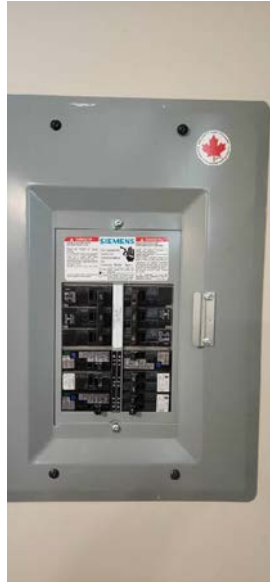
Condition Evidence of a roughed in generator system. For further details and the costs to install a back up generator consult a qualified contractor for recommendations and costs.

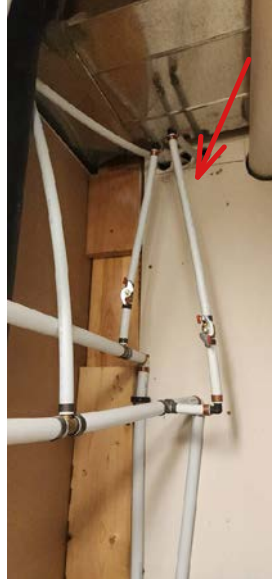
4. Inspected

Interior Supply Piping PEX. Material/condition mentioned here is for those only that were visible at the time of inspection.

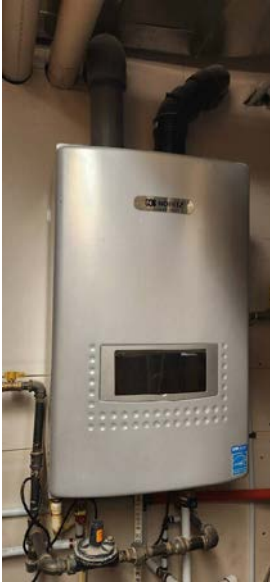
Basement. Mechanical room. Water Heater

2. Type & Energy Source Natural gas, On Demand Approximate Capacity Not applicable.

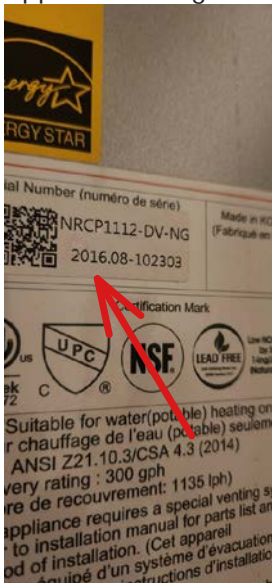
4. Approximate Age 2016. As per serial number

5. Average Life Expectancy Is approximately 10 years with proper maintenance. Even though some do last longer

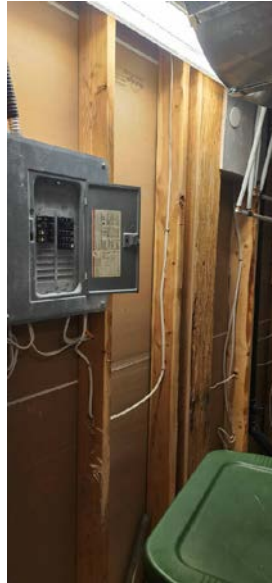
6. Inspected

Interior Structure 2 X 6 construction. Material/condition mentioned here is for those only that were visible at the time of inspection. Other finished walls maybe different.

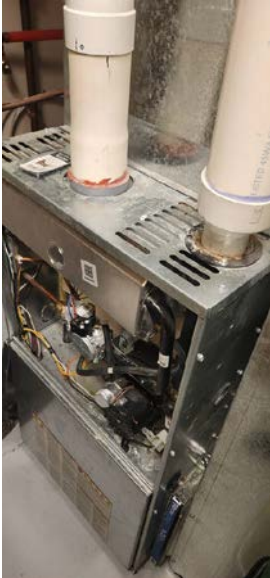
Basement. Mechanical room. Heating System

2. Type High efficiency.

3. Manufacturer Ameristar.

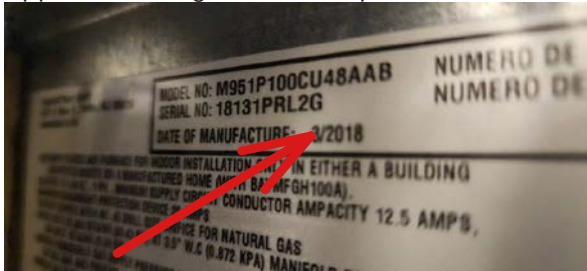
- 4. Fuel Type Natural gas
- 5. Approximate Age 2018., As per label

Condition Consult vendor for functionality and service history. System to be serviced annually before the fall for performance, longevity and safety. After taking possession consult a qualified HVAC contractor for annual servicing, remaining life span and replacement costs.

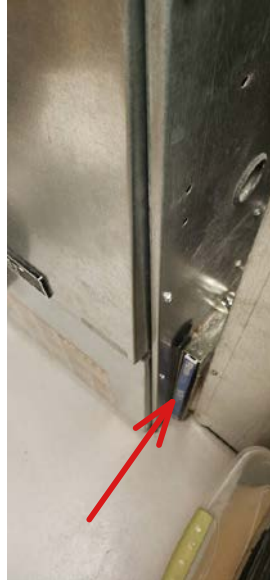
Filter System Disposable. To be replaced approximately every four months.
